Super Salvage, Inc.
Industrial Stormwater Inspection Report

Appendix B

Photograph Log and Photographs

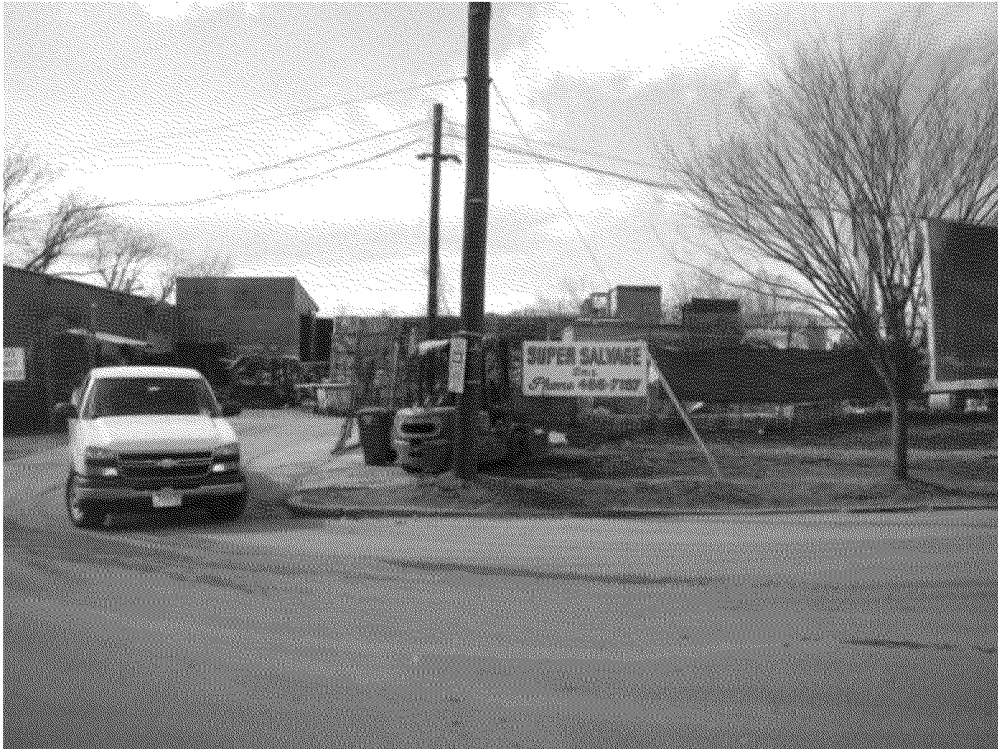
Photograph 1. Facility sign and vehicle track out at Entrance 1.

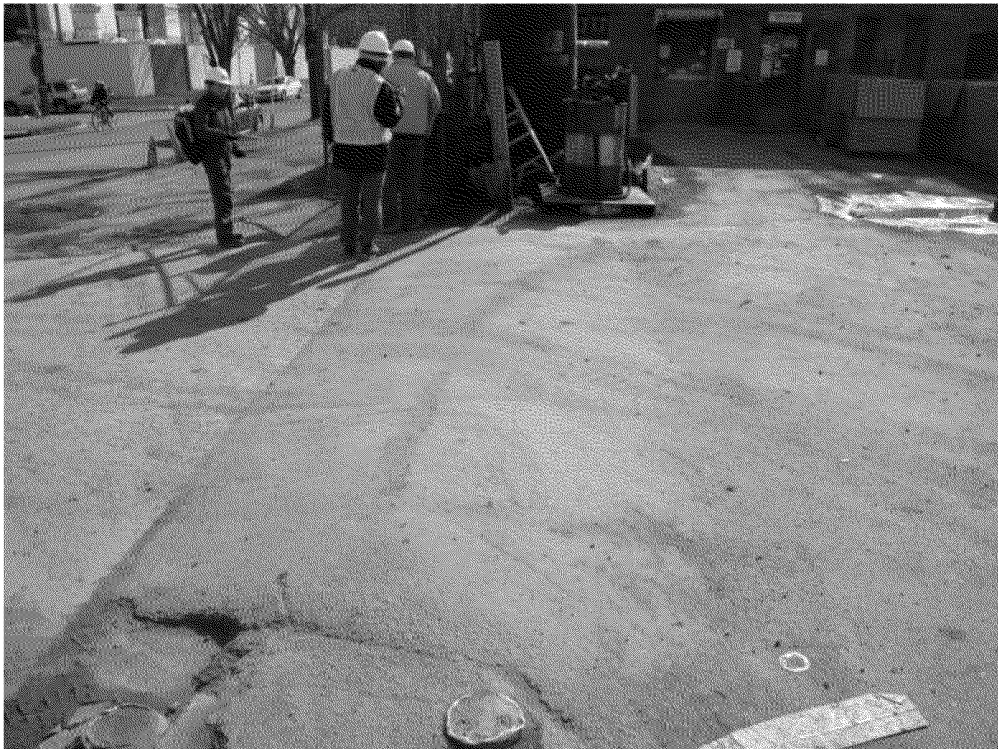
Photograph 2. Berm at Entrance 1 of the site.

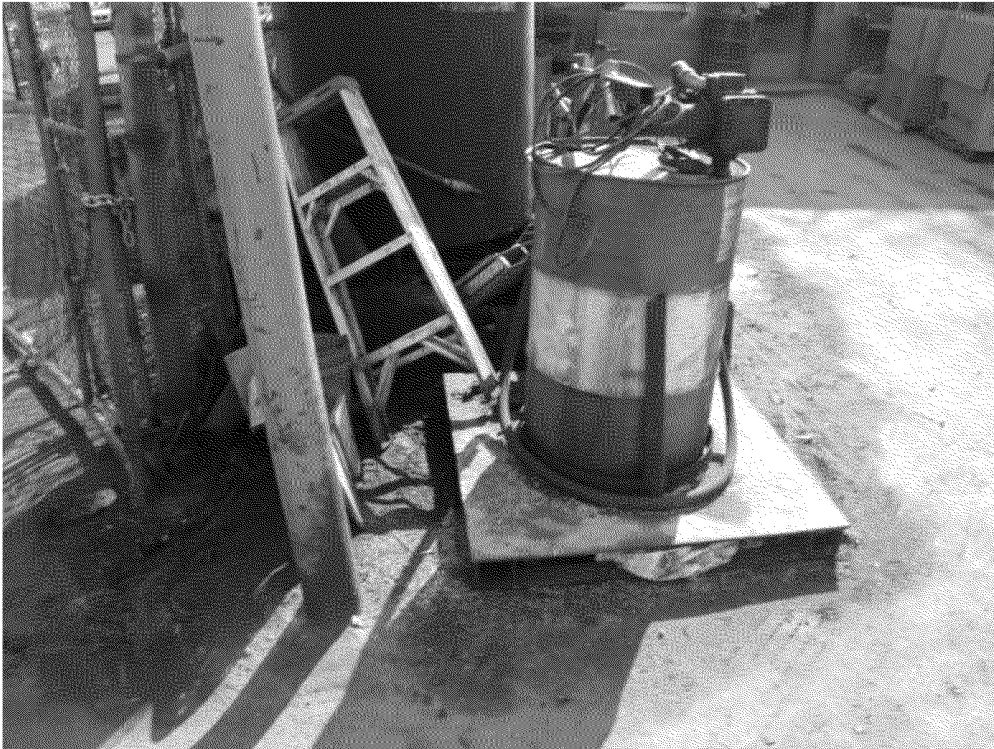
Photograph 3. **Barrel on wooden pallets at Entrance 1 of the site.**

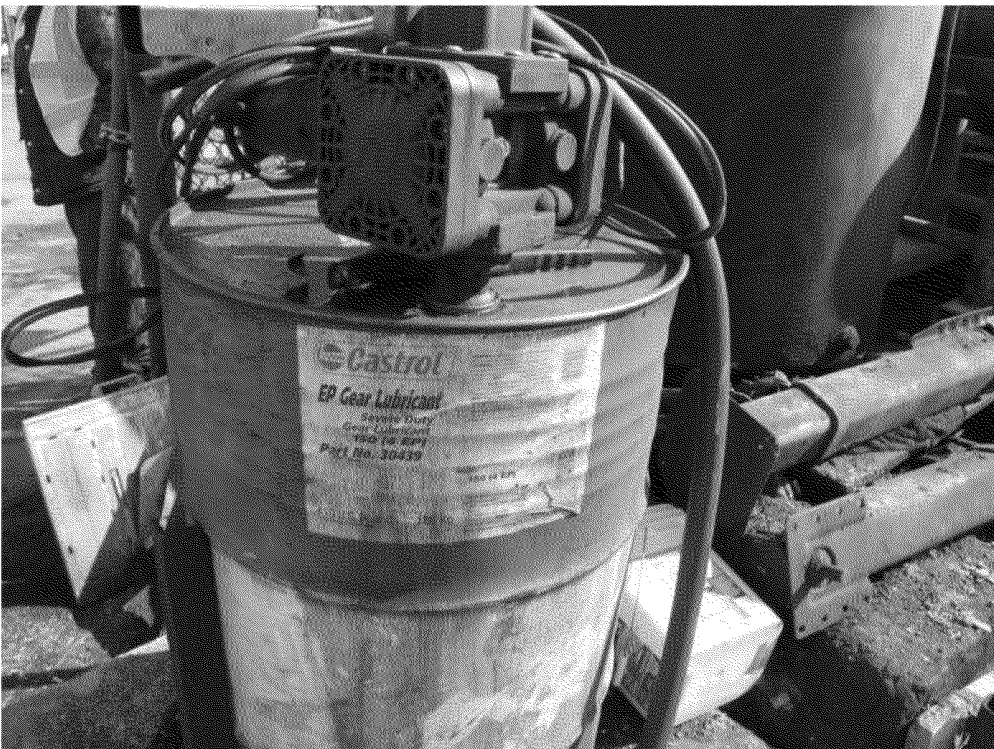
Photograph 4. **Close up view of the lubricant label on the barrel in Photograph 3.**

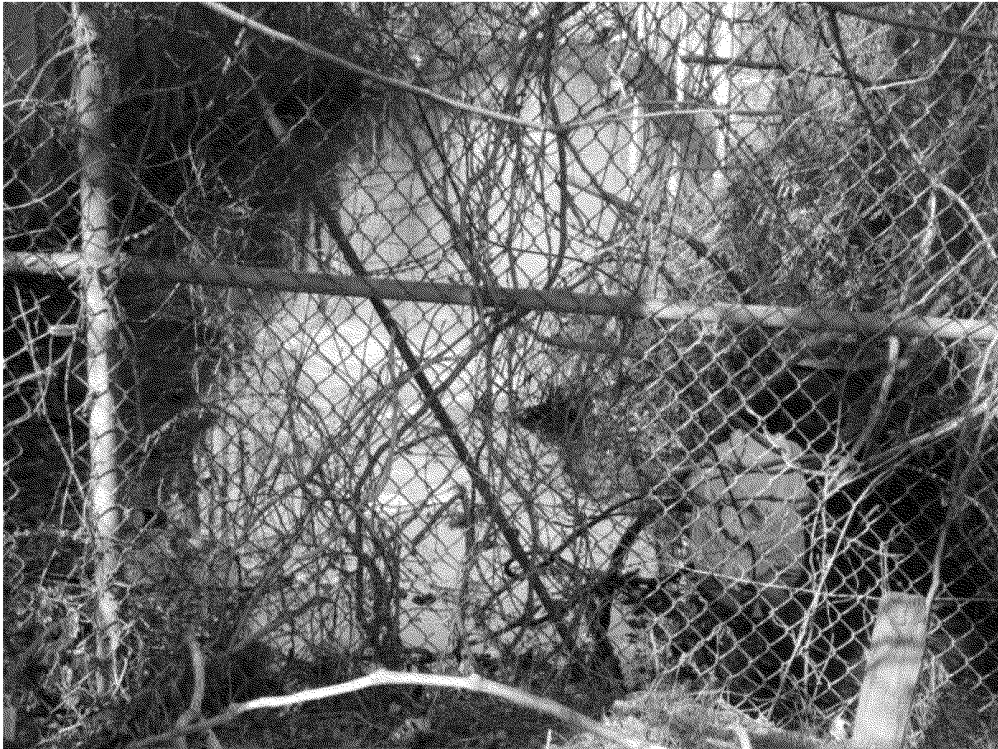
Photograph 5. Overall view of the large runoff collection pond.

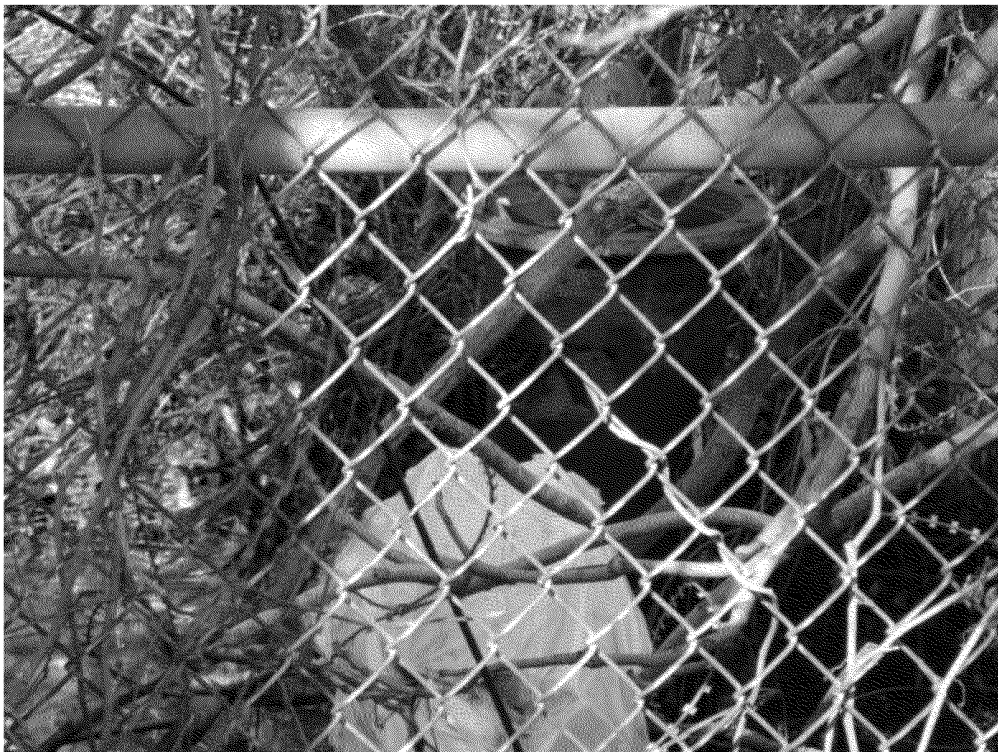
Photograph 6. The riser in the large runoff collection pond.

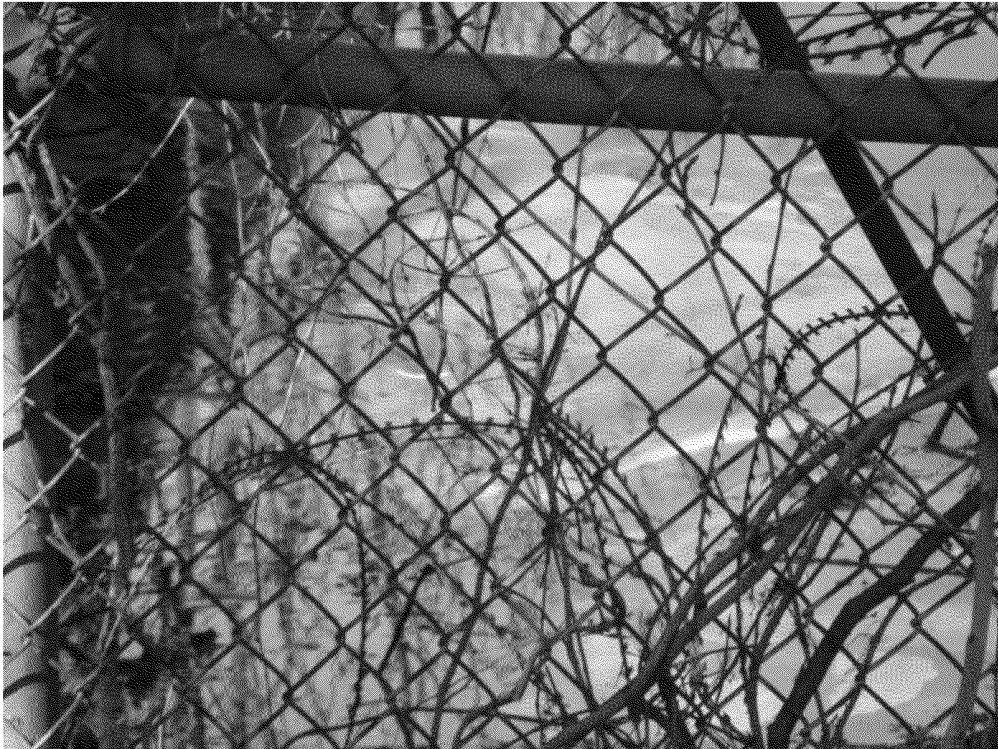
Photograph 7. Close up view of the sheen on the large runoff collection pond.

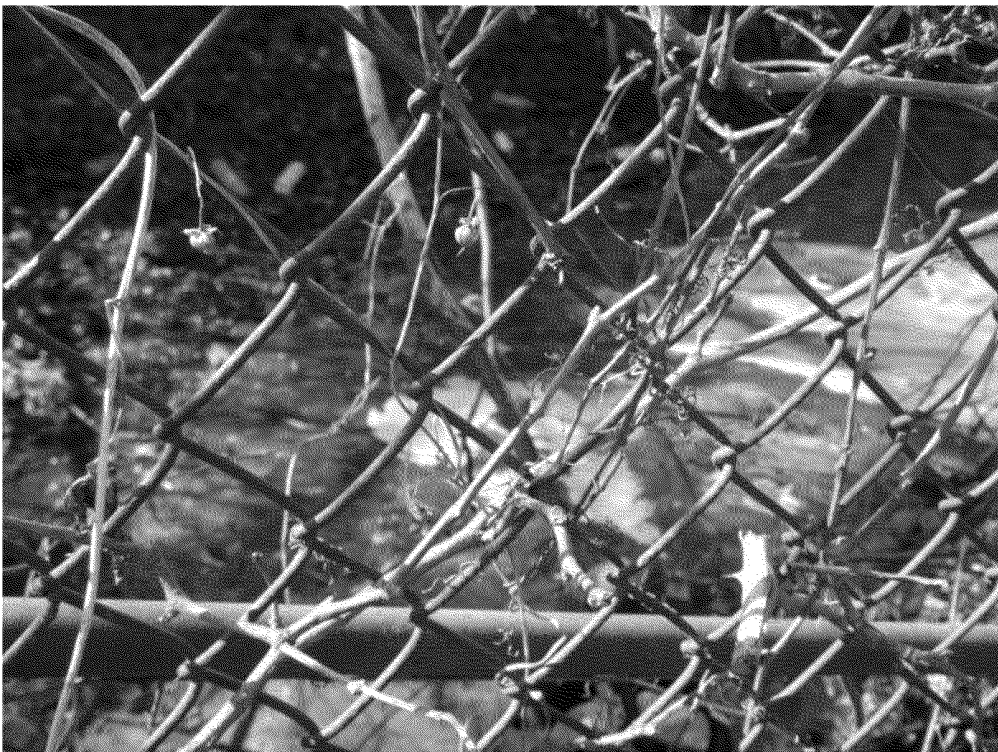
Photograph 8. Alternate view of the sheen on the large runoff collection pond.

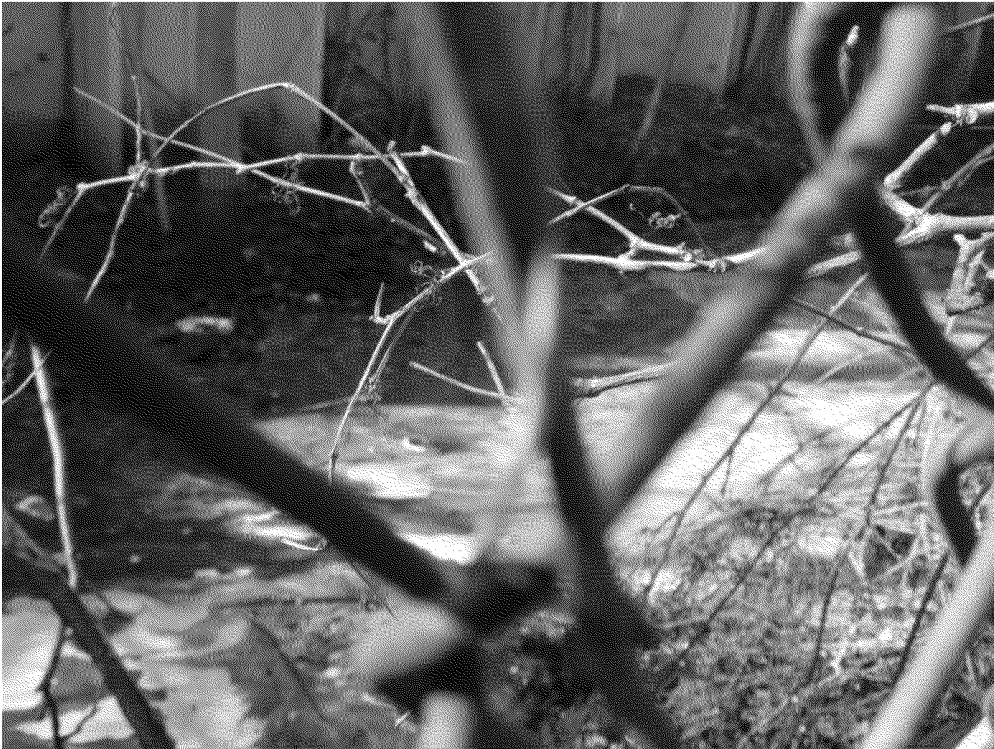
Photograph 9. View of the sheen on the large runoff collection pond.

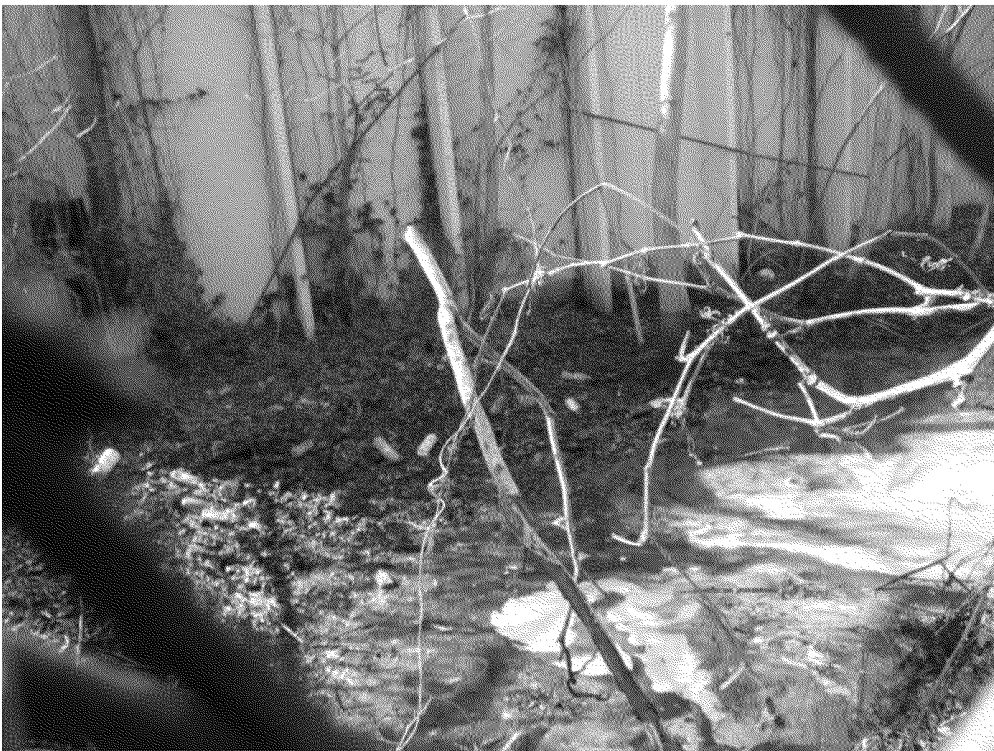
Photograph 10. View of the sheen on the large runoff collection pond.

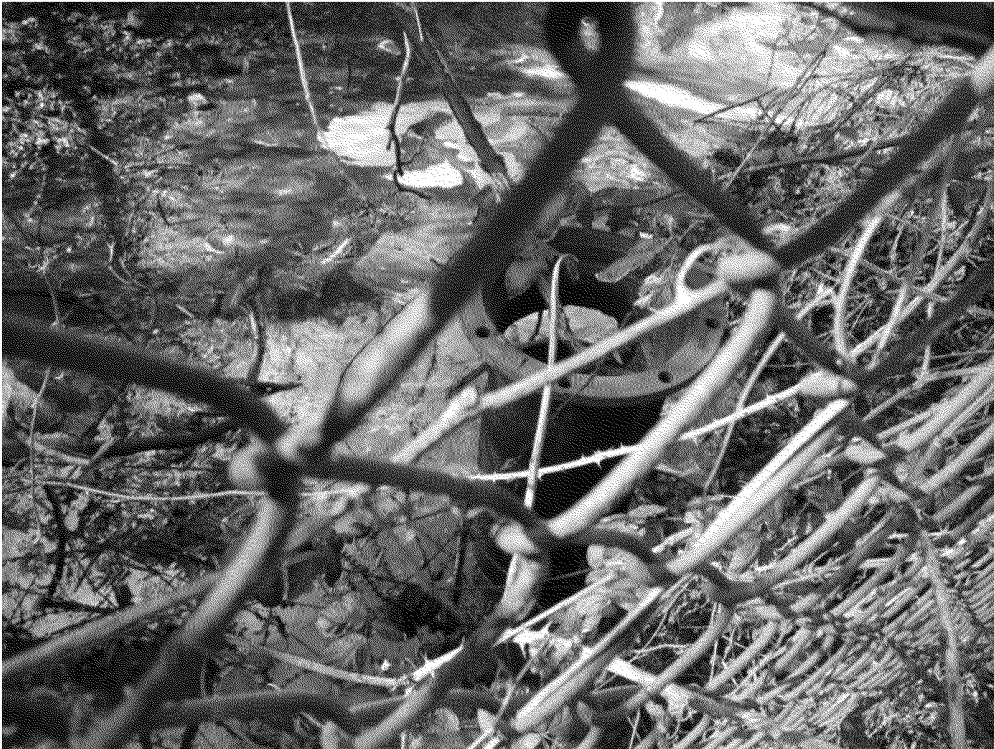
Photograph 11. View of the sheen on the large runoff collection pond with the riser.

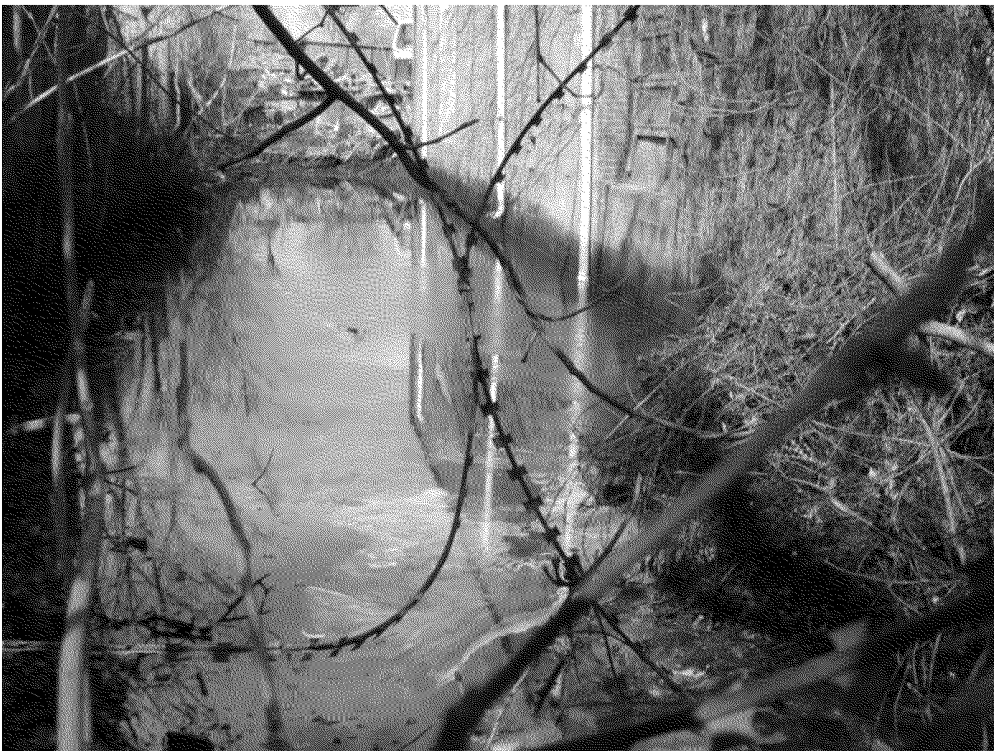
Photograph 12. The water elevation line height as indicated on side of the building.

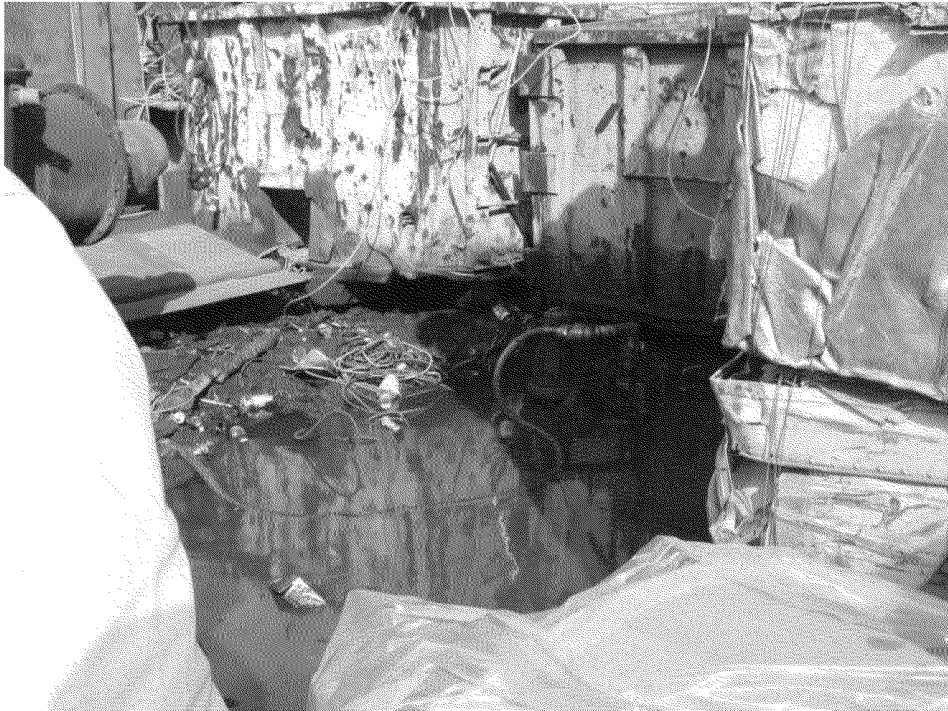
Photograph 13. Small runoff collection pond with a manual pump near the center of the scrap yard.

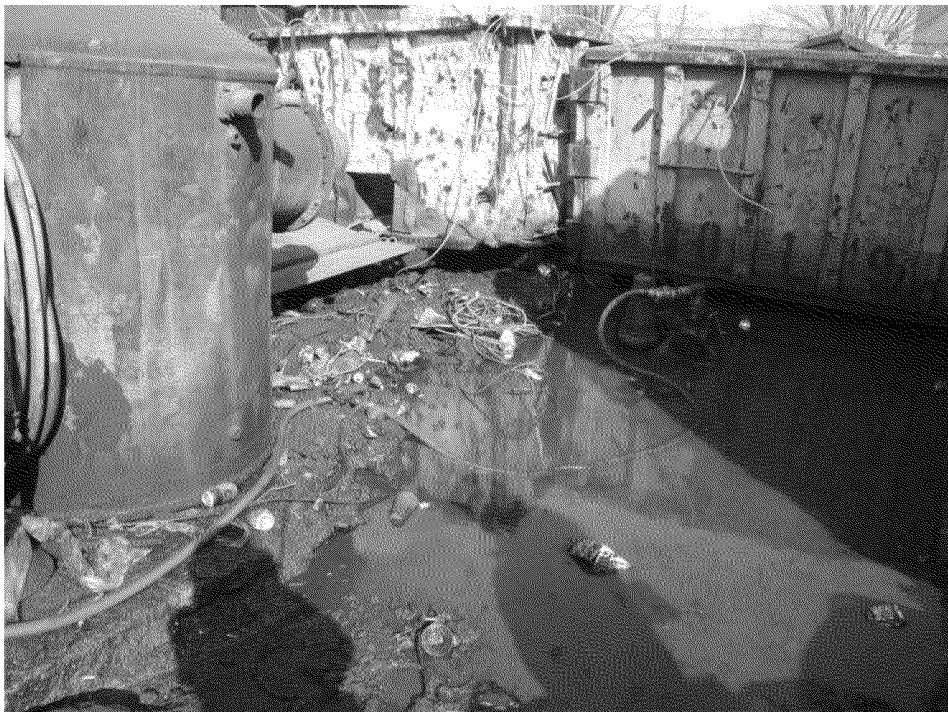
Photograph 14. Alternate view of the small runoff collection pond with the manual pump.

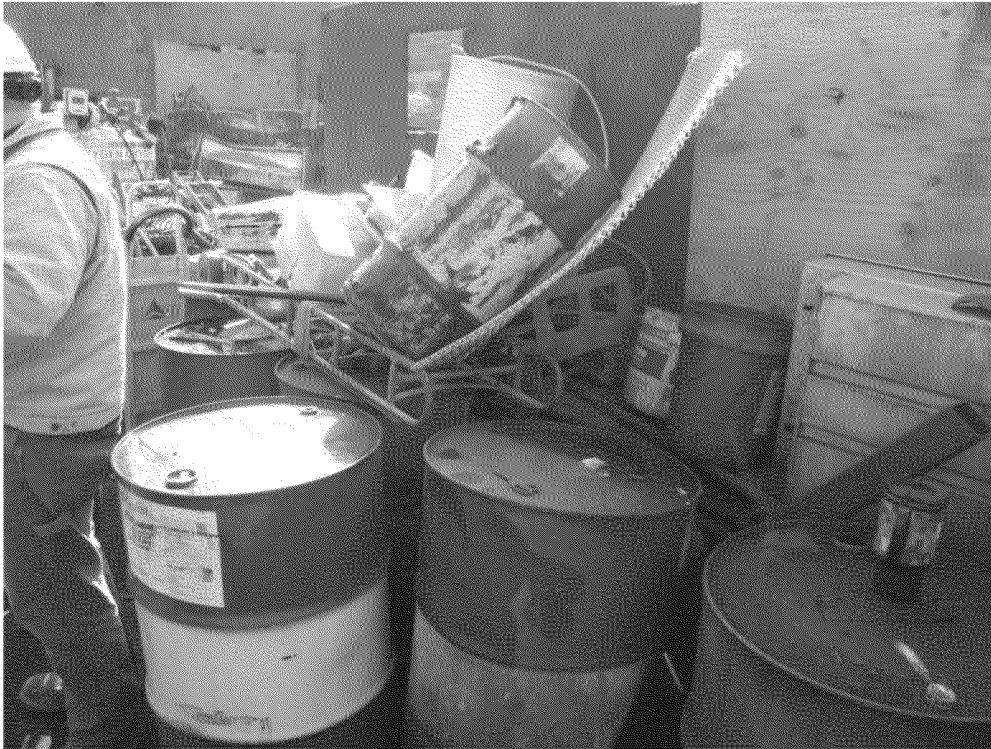
Photograph 15. Storage of drums adjacent to small runoff collection pond.

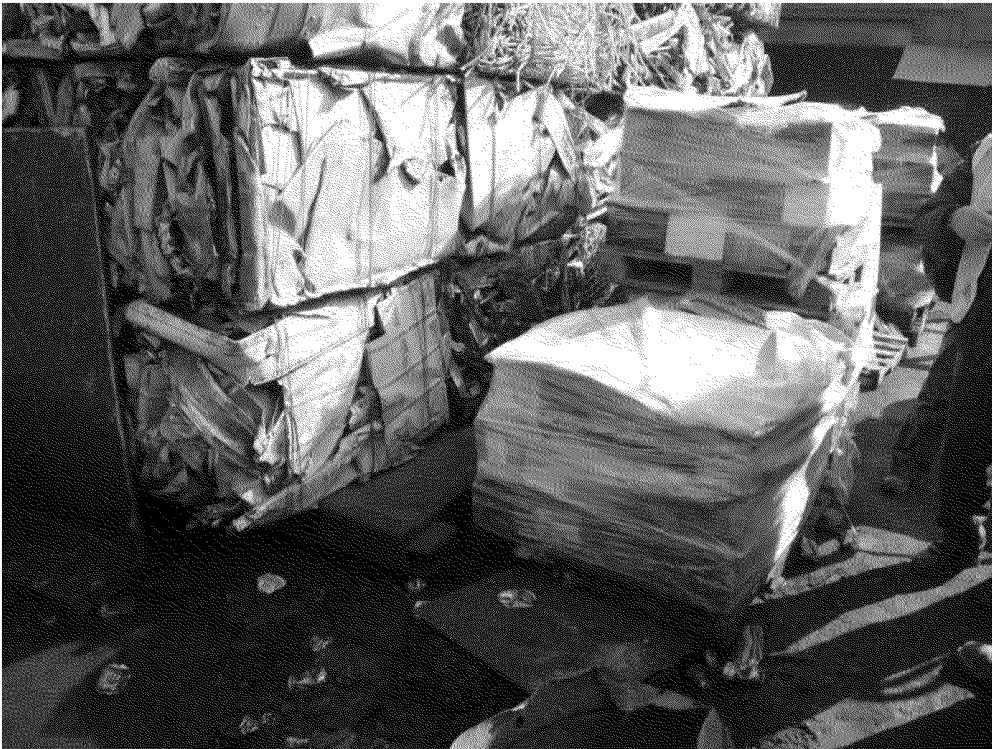
Photograph 16. Pallets of used car batteries adjacent to small runoff collection pond.

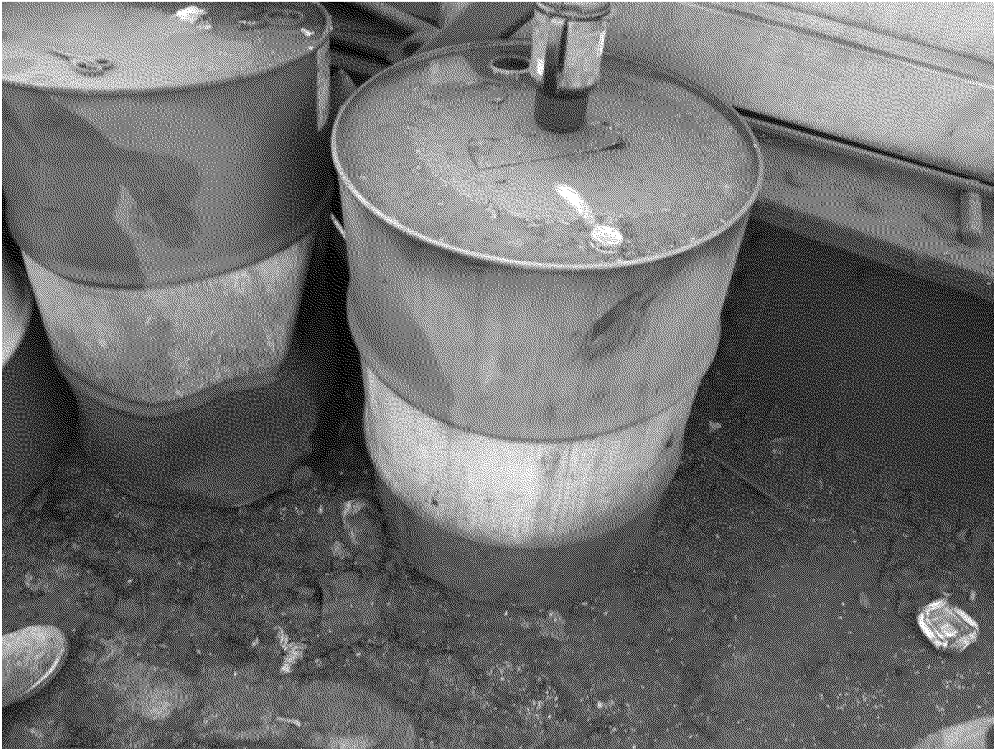
Photograph 17. **Alternate view of drums with what appeared to be oil staining.**

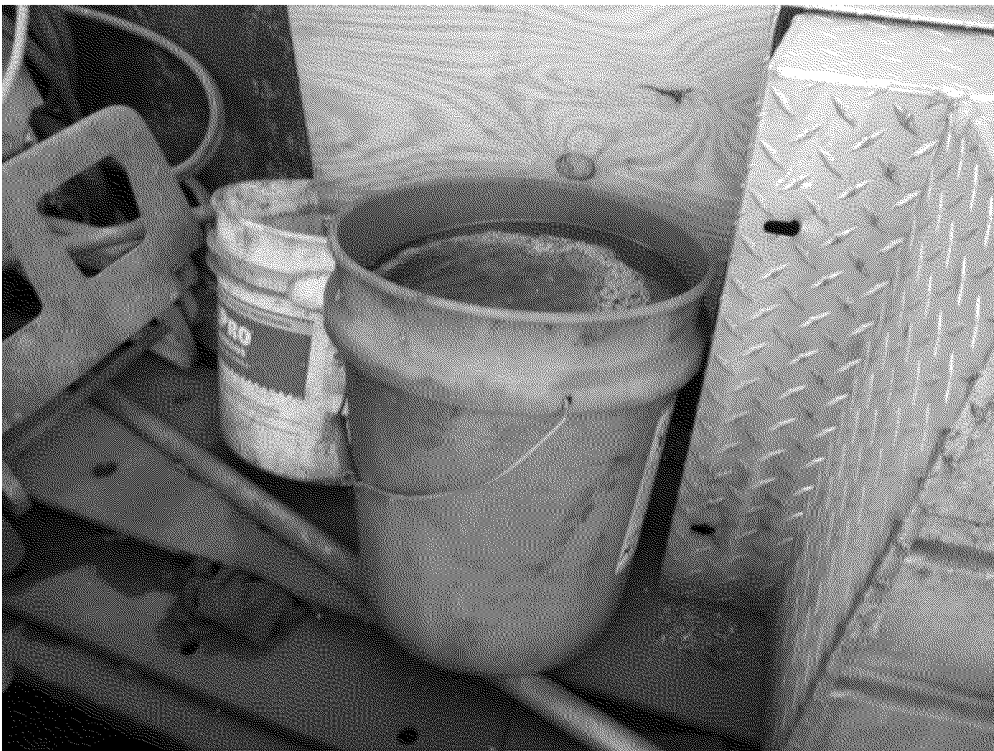
Photograph 18. **Close-up view of an open bucket also visible in Photograph 16.**

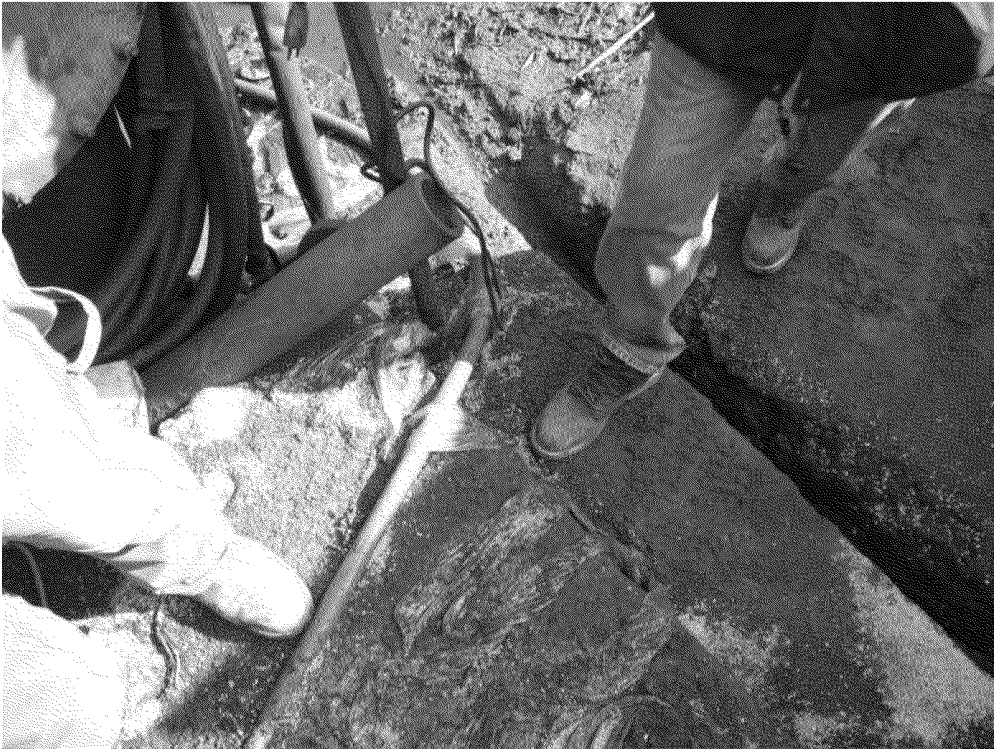
Photograph 19. Trench leading to the small runoff collection pond.

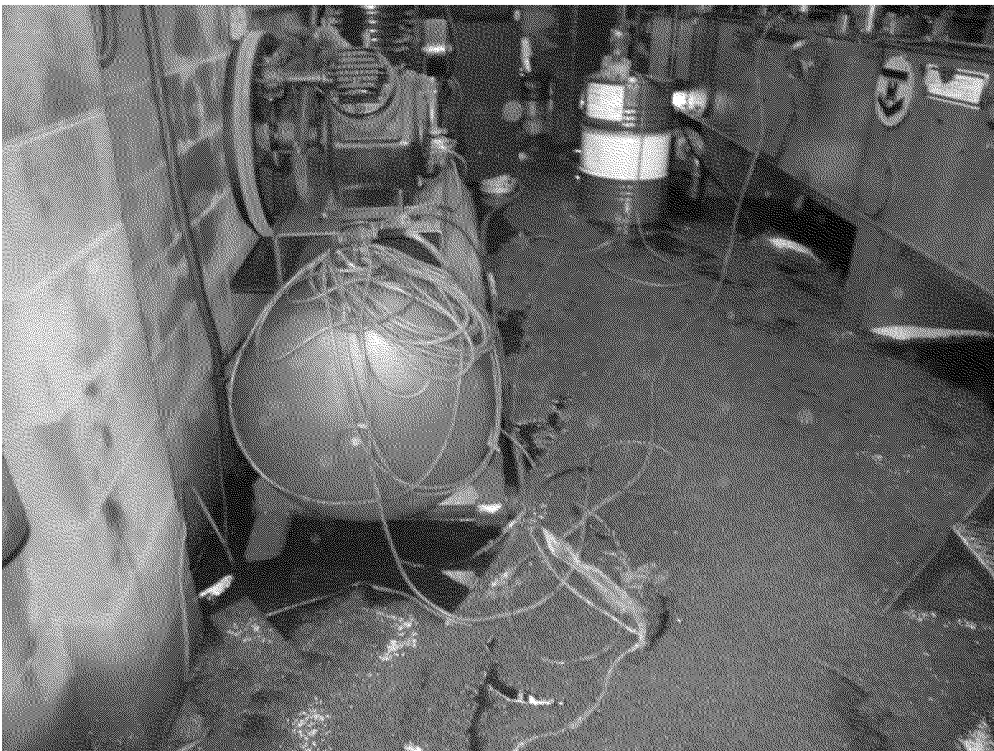
Photograph 20. Pooled fluids and saturated absorbent materials.

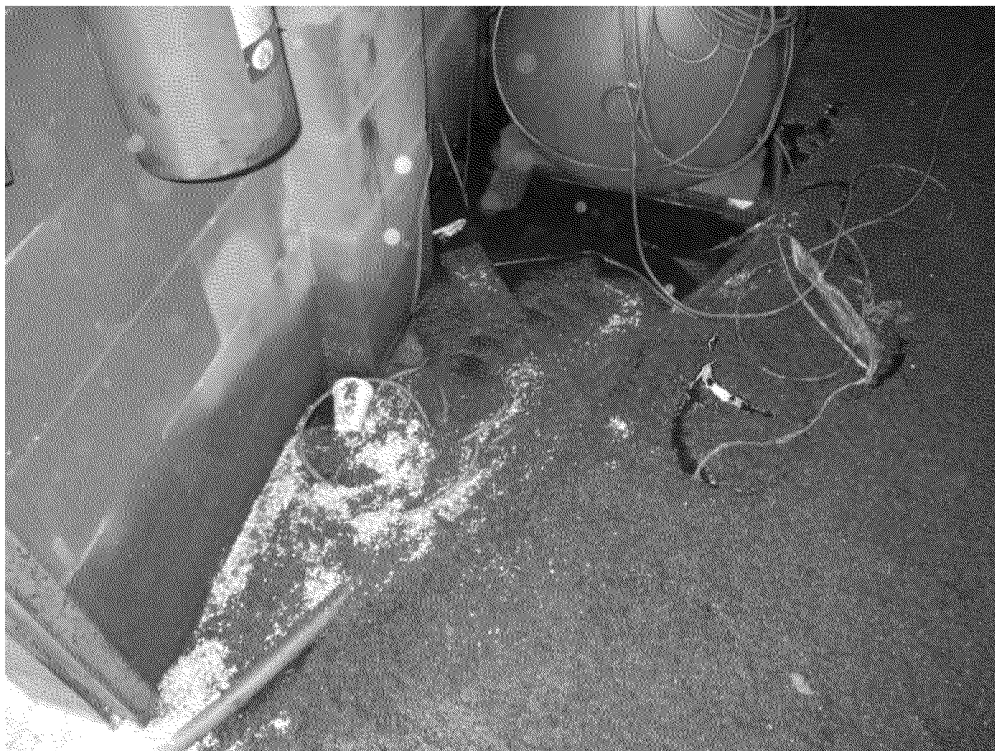
Photograph 21. **Alternate view of Photograph 20.**

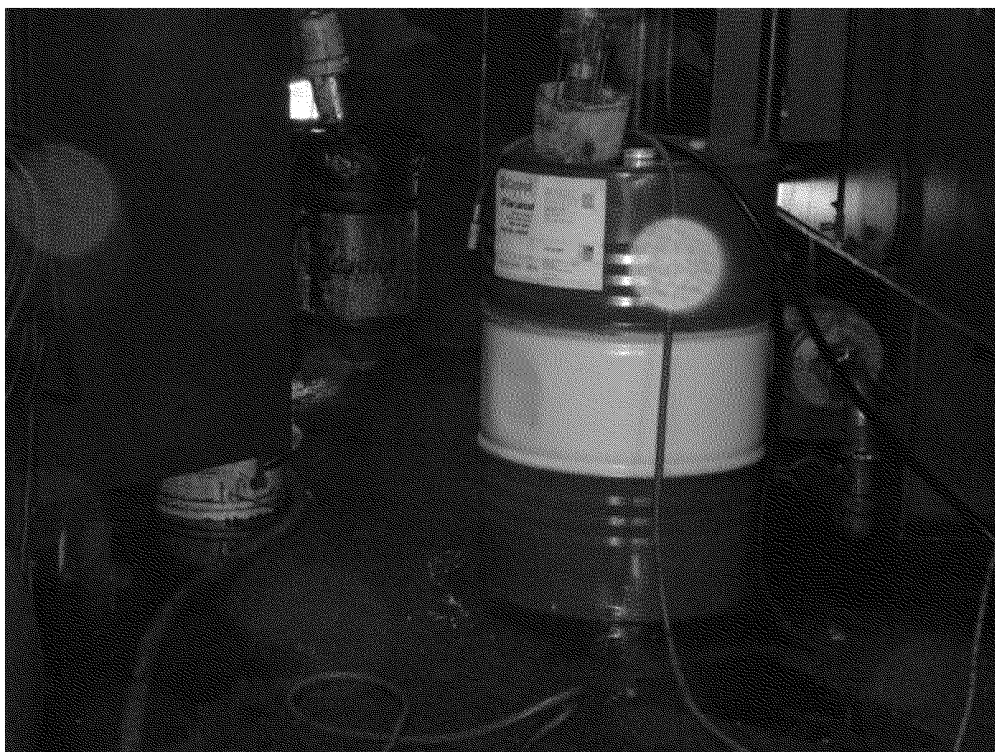
Photograph 22. **Close-up of two tanks in the building leaking onto the floor.**

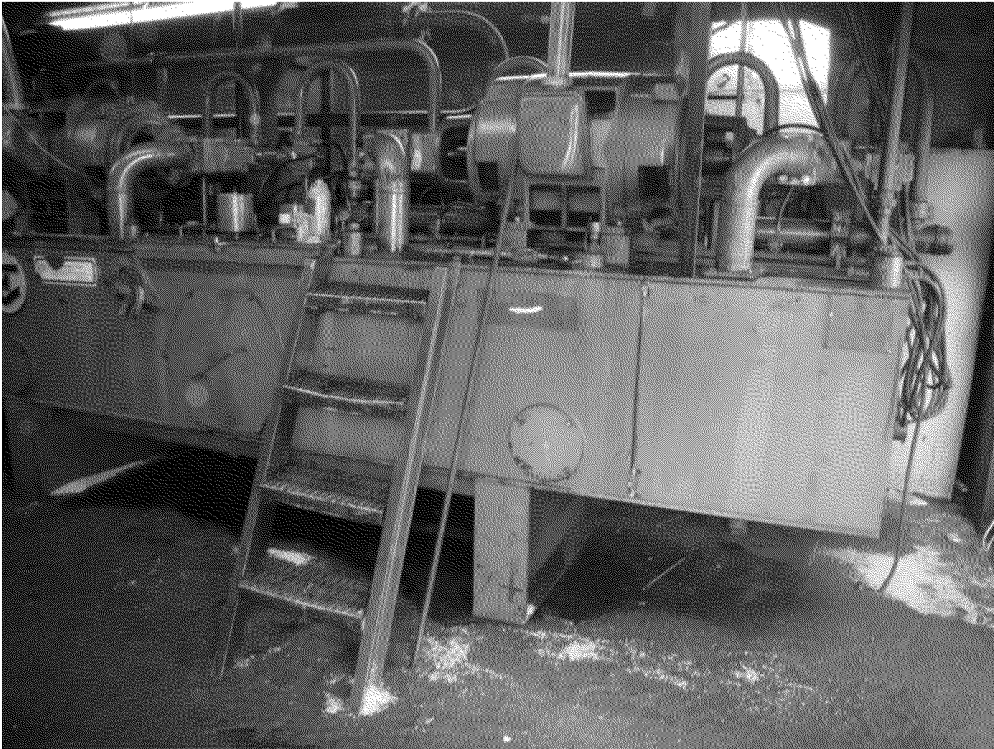
Photograph 23. **Hydraulic machinery with what appears to be oil underneath.**

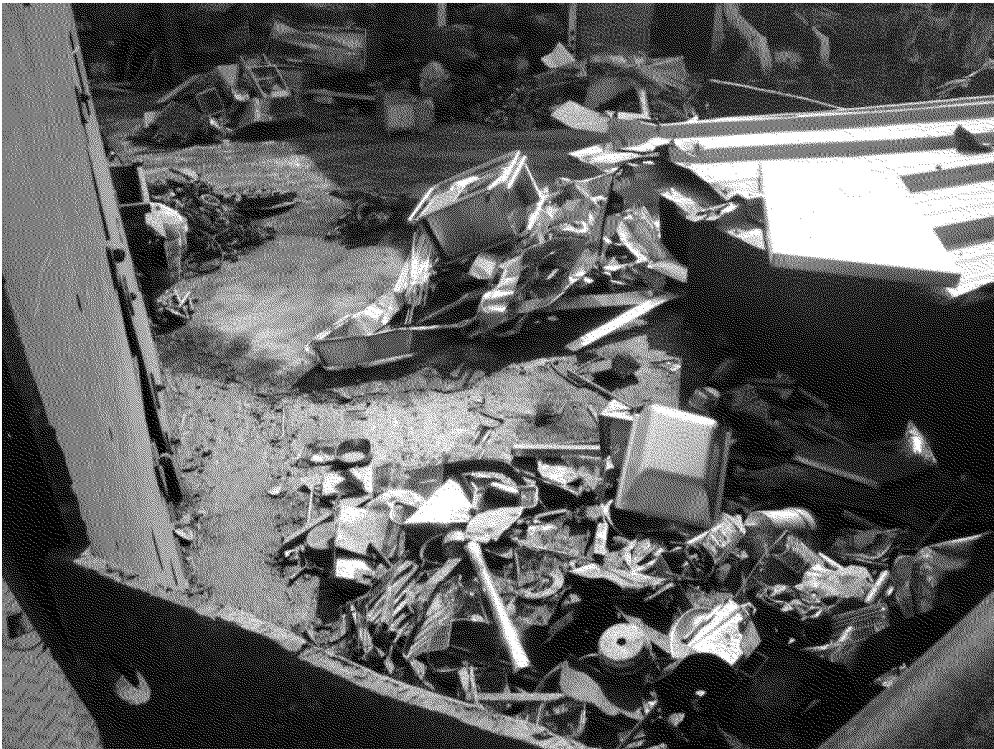
Photograph 24. **Debris from metal separation.**

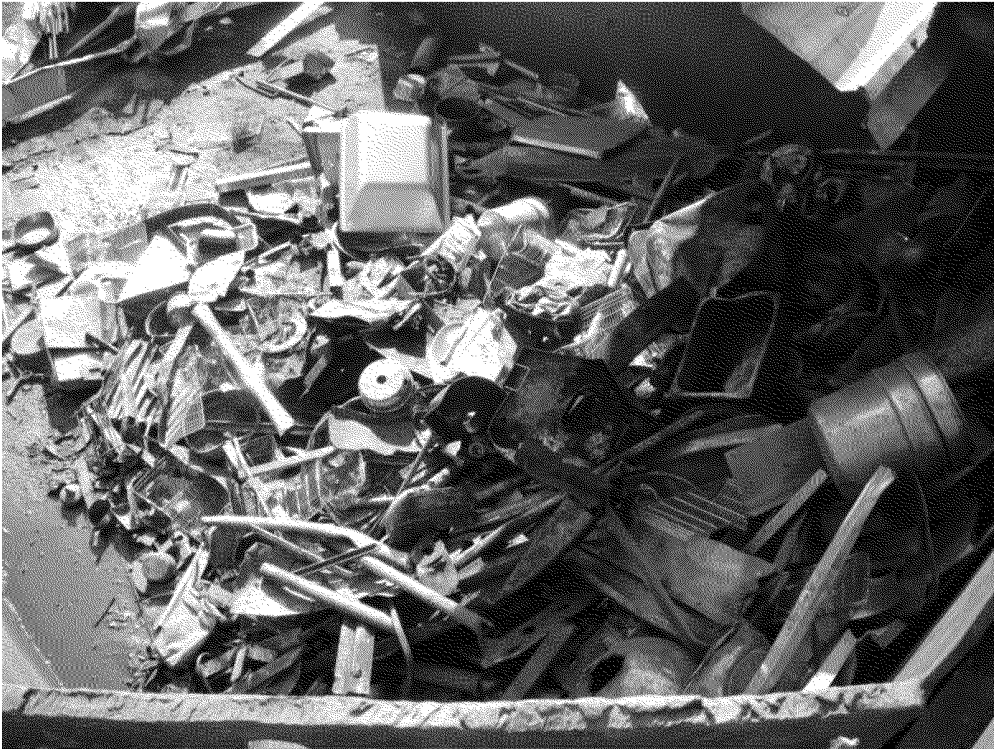
Photograph 25. Alternate view of the debris including fluid pooling to the left.

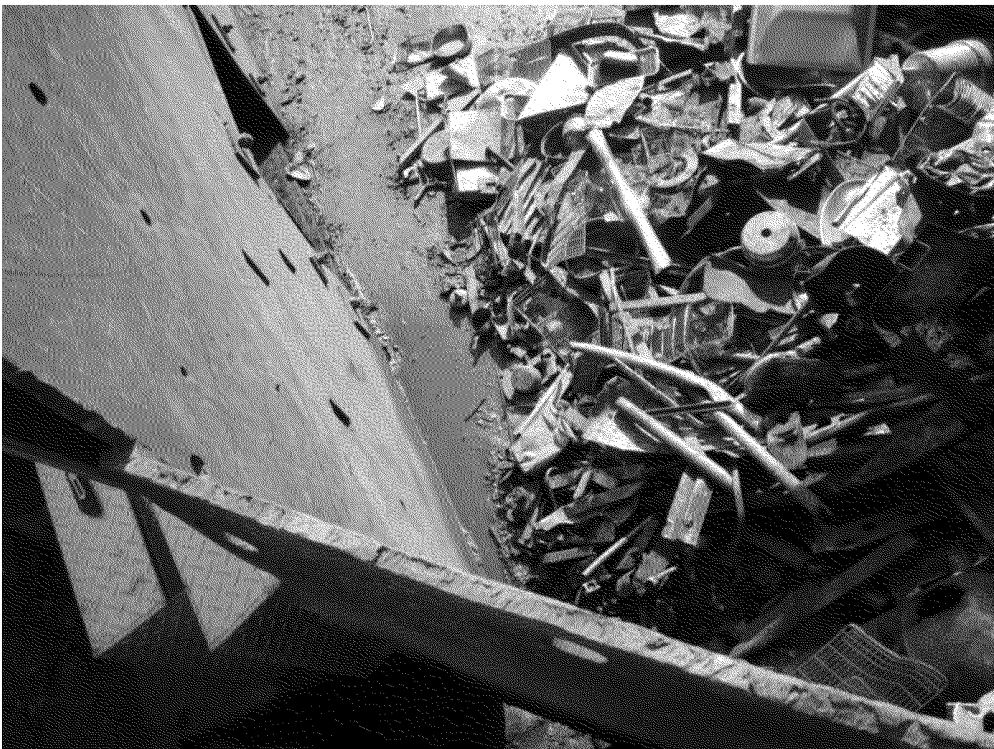
Photograph 26. Alternate view of the fluid pooling towards the trench.

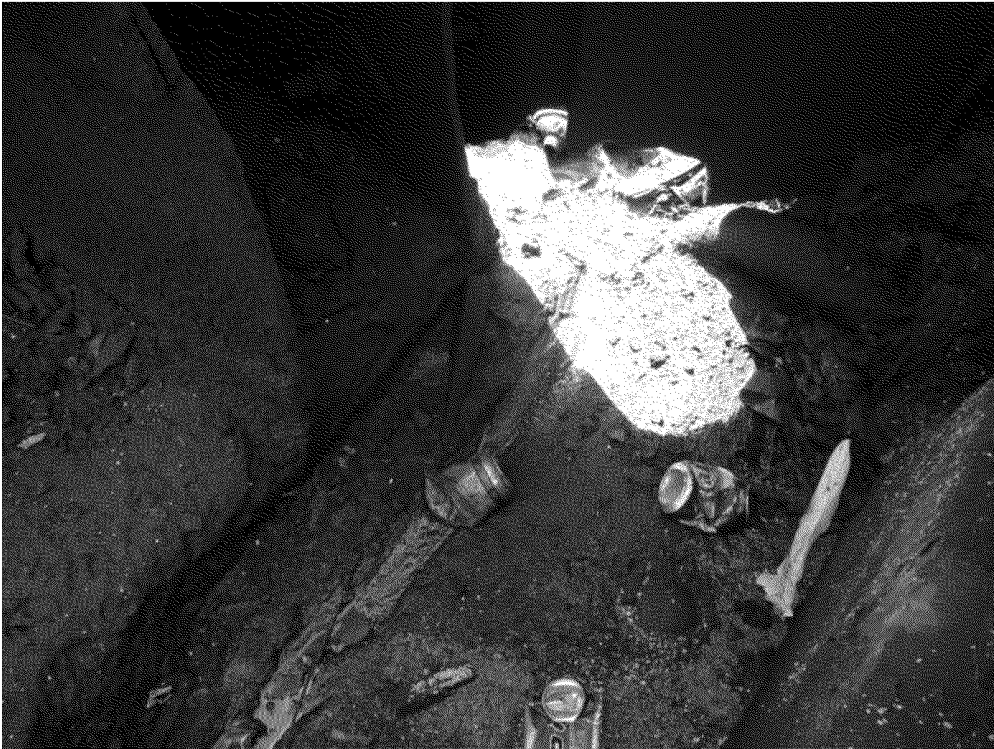
Photograph 29. Entrance to the trench.

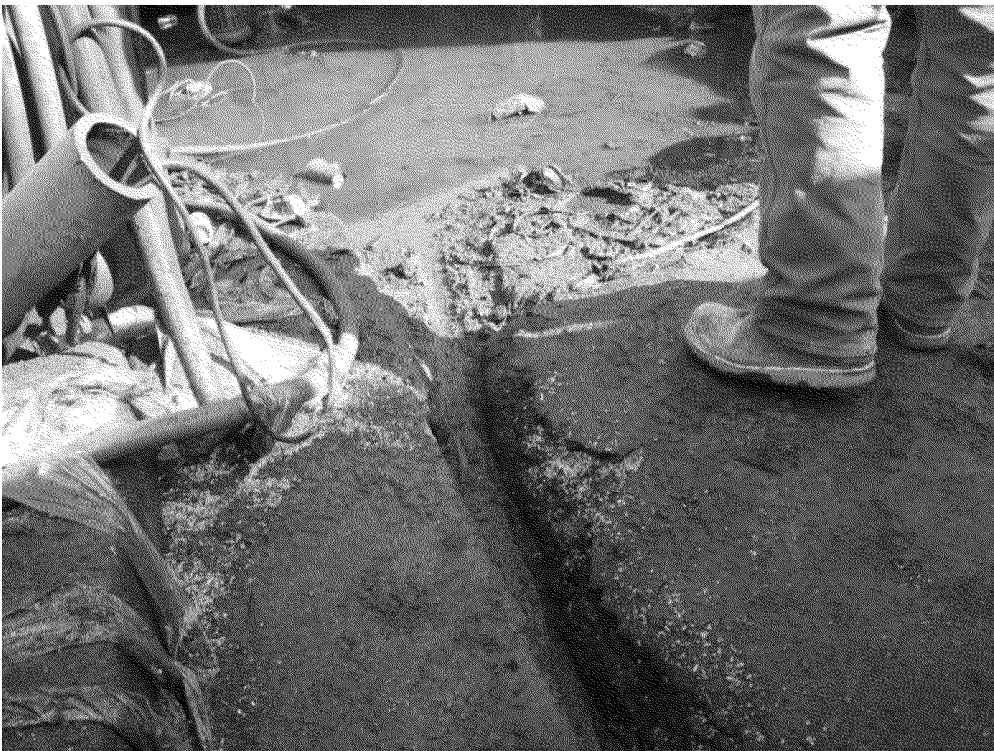
Photograph 30. The end of the trench leading into the small runoff collection pond.

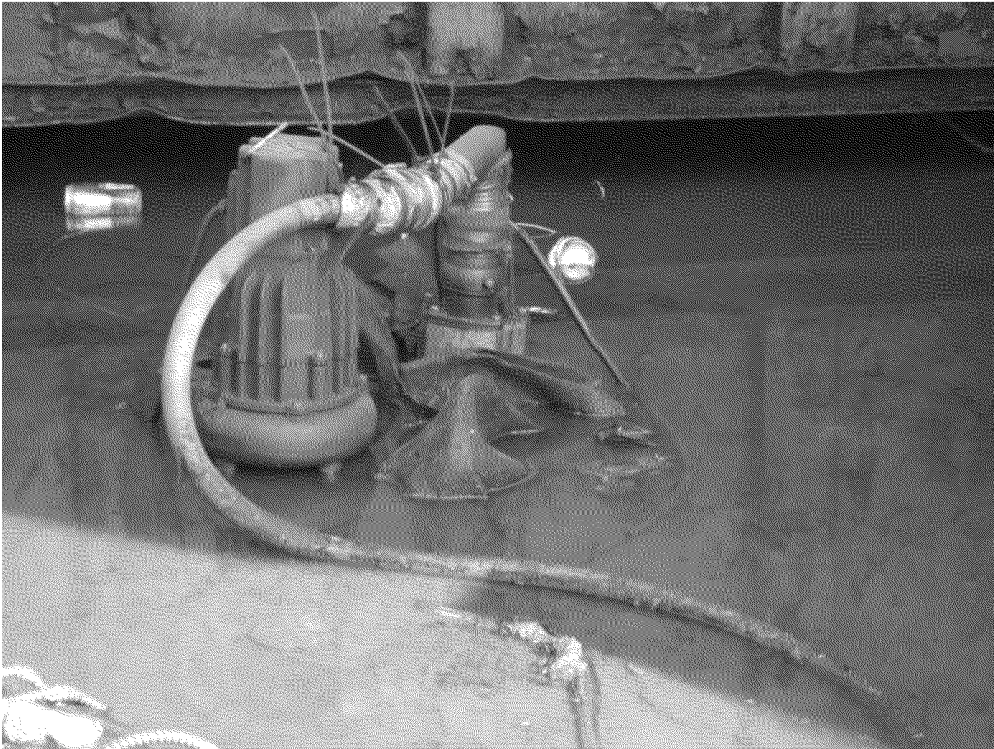
Photograph 31. Close-up view of the manual pump in the small runoff collection pond.

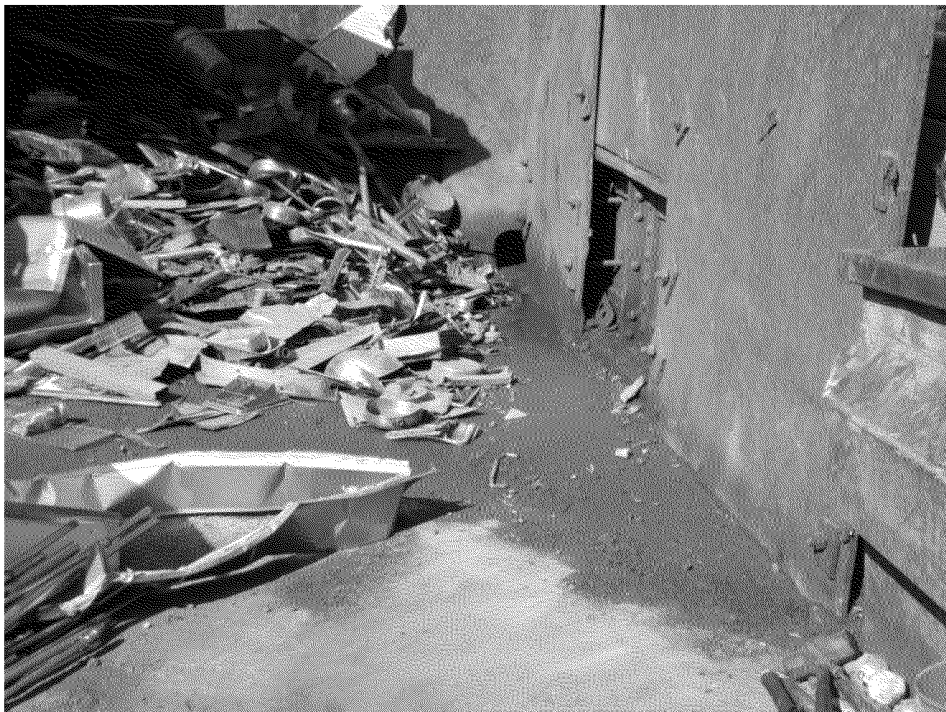
Photograph 32. Alternate view of the entrance to the trench from the opposite side of the wall shown in Photograph 30.
